CONCEPTUAL
MASTERPLAN
11-08-16
David & Jamie
Addington
298 St. James Dr
Piedmont, CA

Subject:
Summary Report
PG&E Towers Soil Removal
298 Saint James Drive
Piedmont, California

On behalf of Pacific Gas and Electric Company (PG&E), Arcadis, U.S., Inc. prepared this Summary Report to discuss the soil restoration activities completed at the PG&E towers located at 298 Saint James Drive, Piedmont, California.

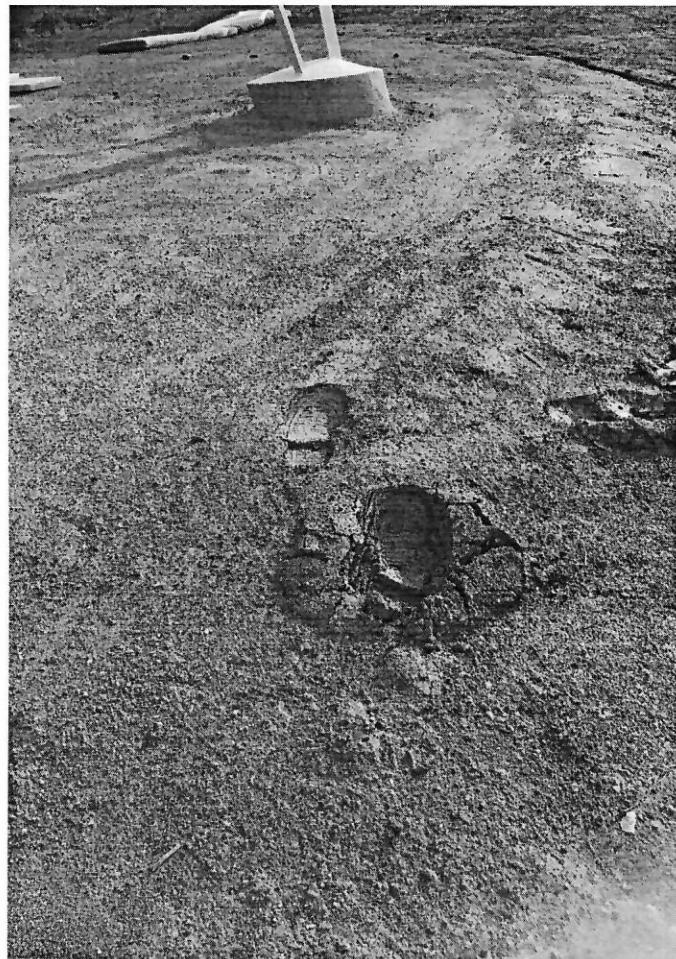
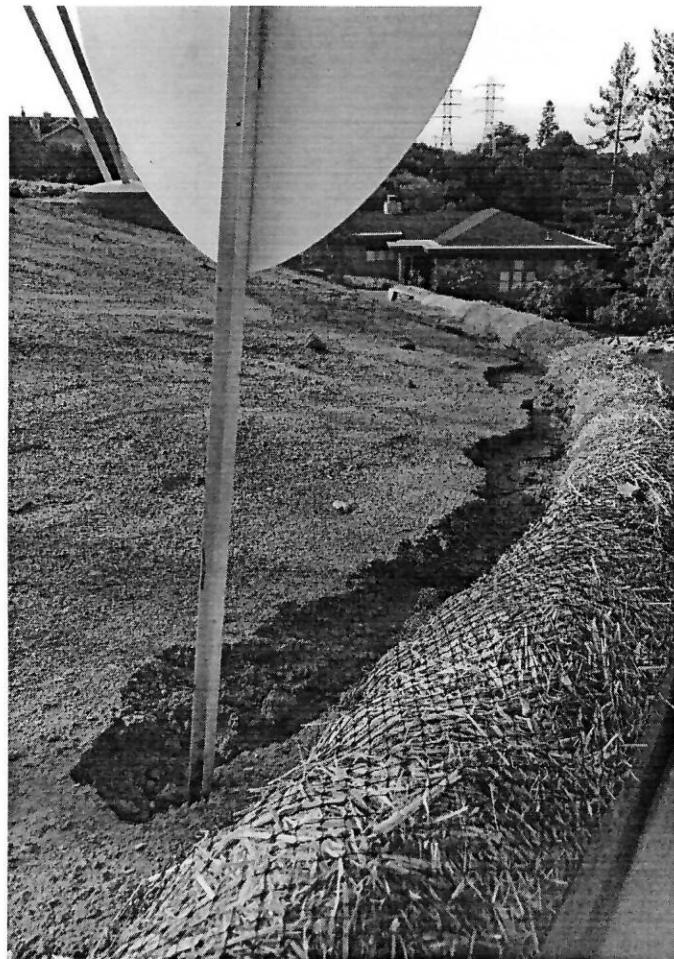
As the pictures attached show, the site is untenable. I sunk in 6 inches when walking it yesterday with the Gary Rapp. So if I did not ask before, I would like to also get data on soil type that was used and compaction report or similar.
